**Scottish Water**

**Milngavie Reservoirs  
Landscape Site  
Management Plan  
Management Action  
Plan**

**Final Report**  
Prepared by LUC  
February 2024

**Project Number**  
 12413

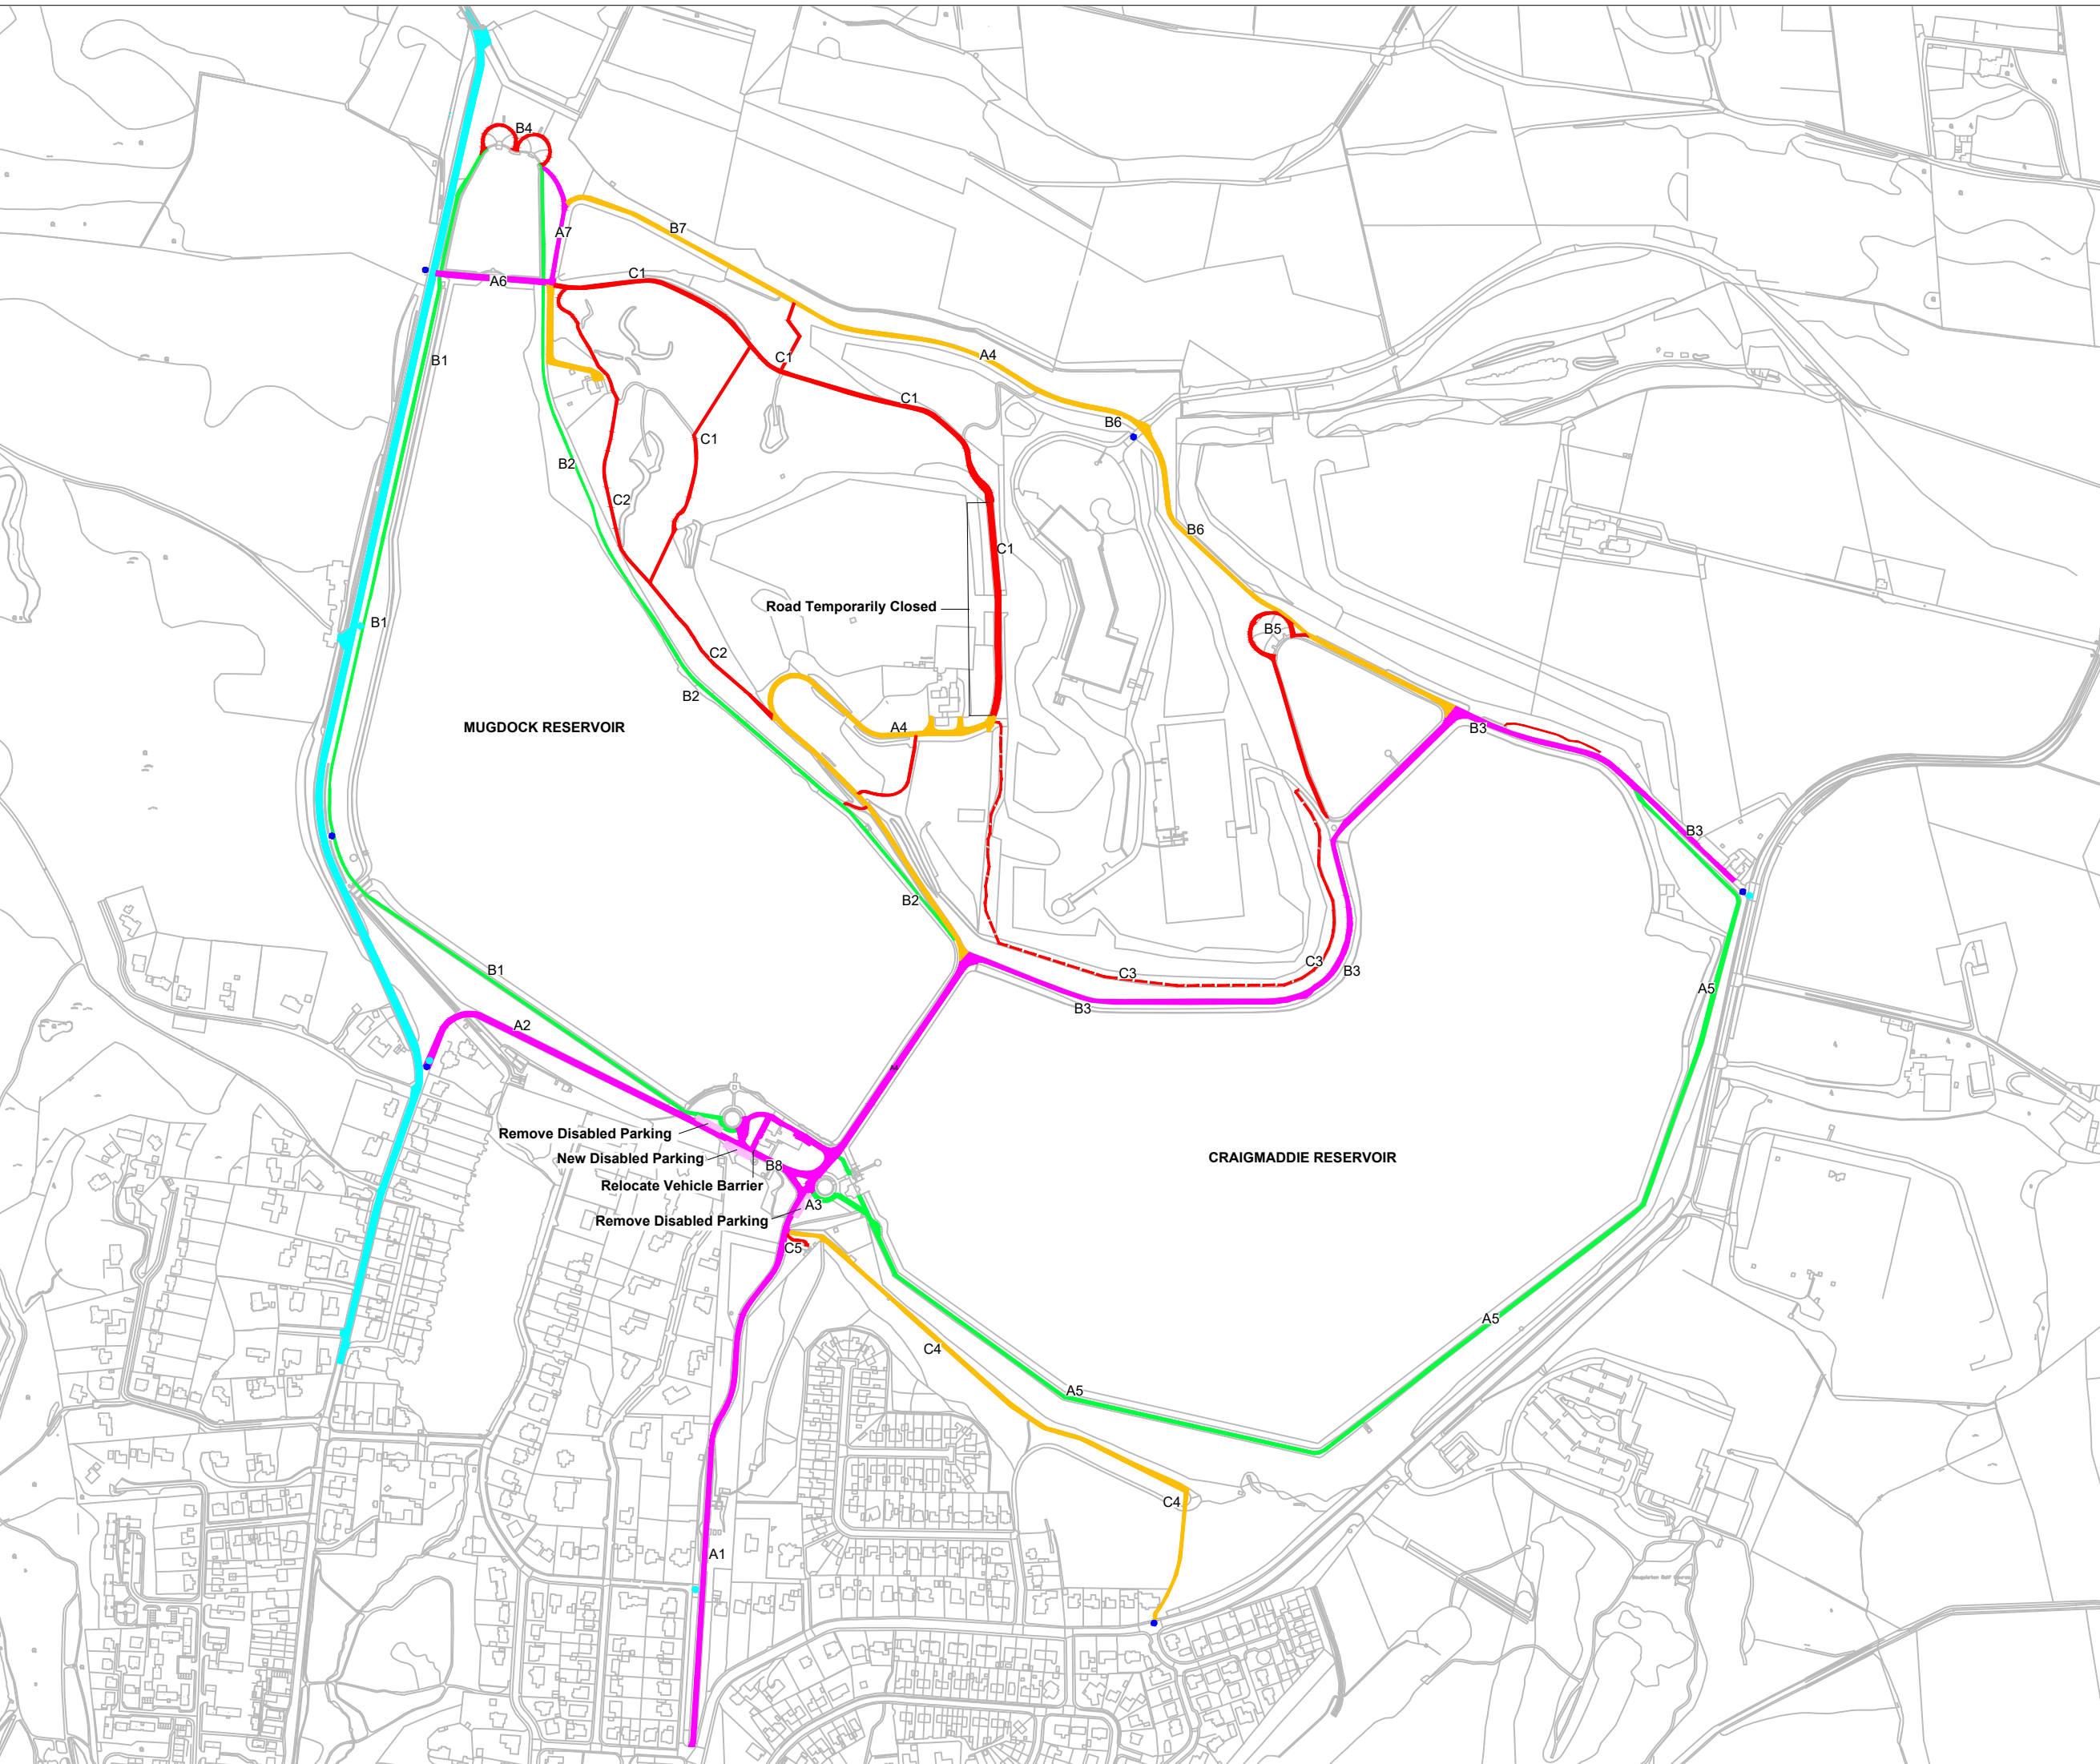
Fig. 3 Access Routes

**2.37** In addition to the unmetalled roads and paths there are numerous informal routes which are unsurfaced, some of which are 'desire-lines'. These routes are generally less accessible due to the gradients and ground conditions. However, they provide a valuable alternative for those who want to explore and experience the less visited parts of the landscape. Some routes may involve health & safety risks due to gradients etc. and consequently upgrades should be focussed on the most well used routes. Appropriate information on the potential access risks and constraints should be provided on site information signs. The audit has identified the following informal routes as shown on **Fig 3**. These are as follows:

**2.43** We recommend that the use and condition of informal routes be monitored to determine whether they can be retained as unsurfaced/ grass paths or whether footfall creates erosion/ ponding problems. Simple interventions to improve the route ground conditions and to remove obstacles (such as fallen trees and broken fences) should be undertaken. Low branches and deadwood overhanging paths should ideally be removed for access and safety reasons. Repair of historic structures close to these routes should also be undertaken where it can improve the safety and amenity of the routes. Eg repair of old field walls.

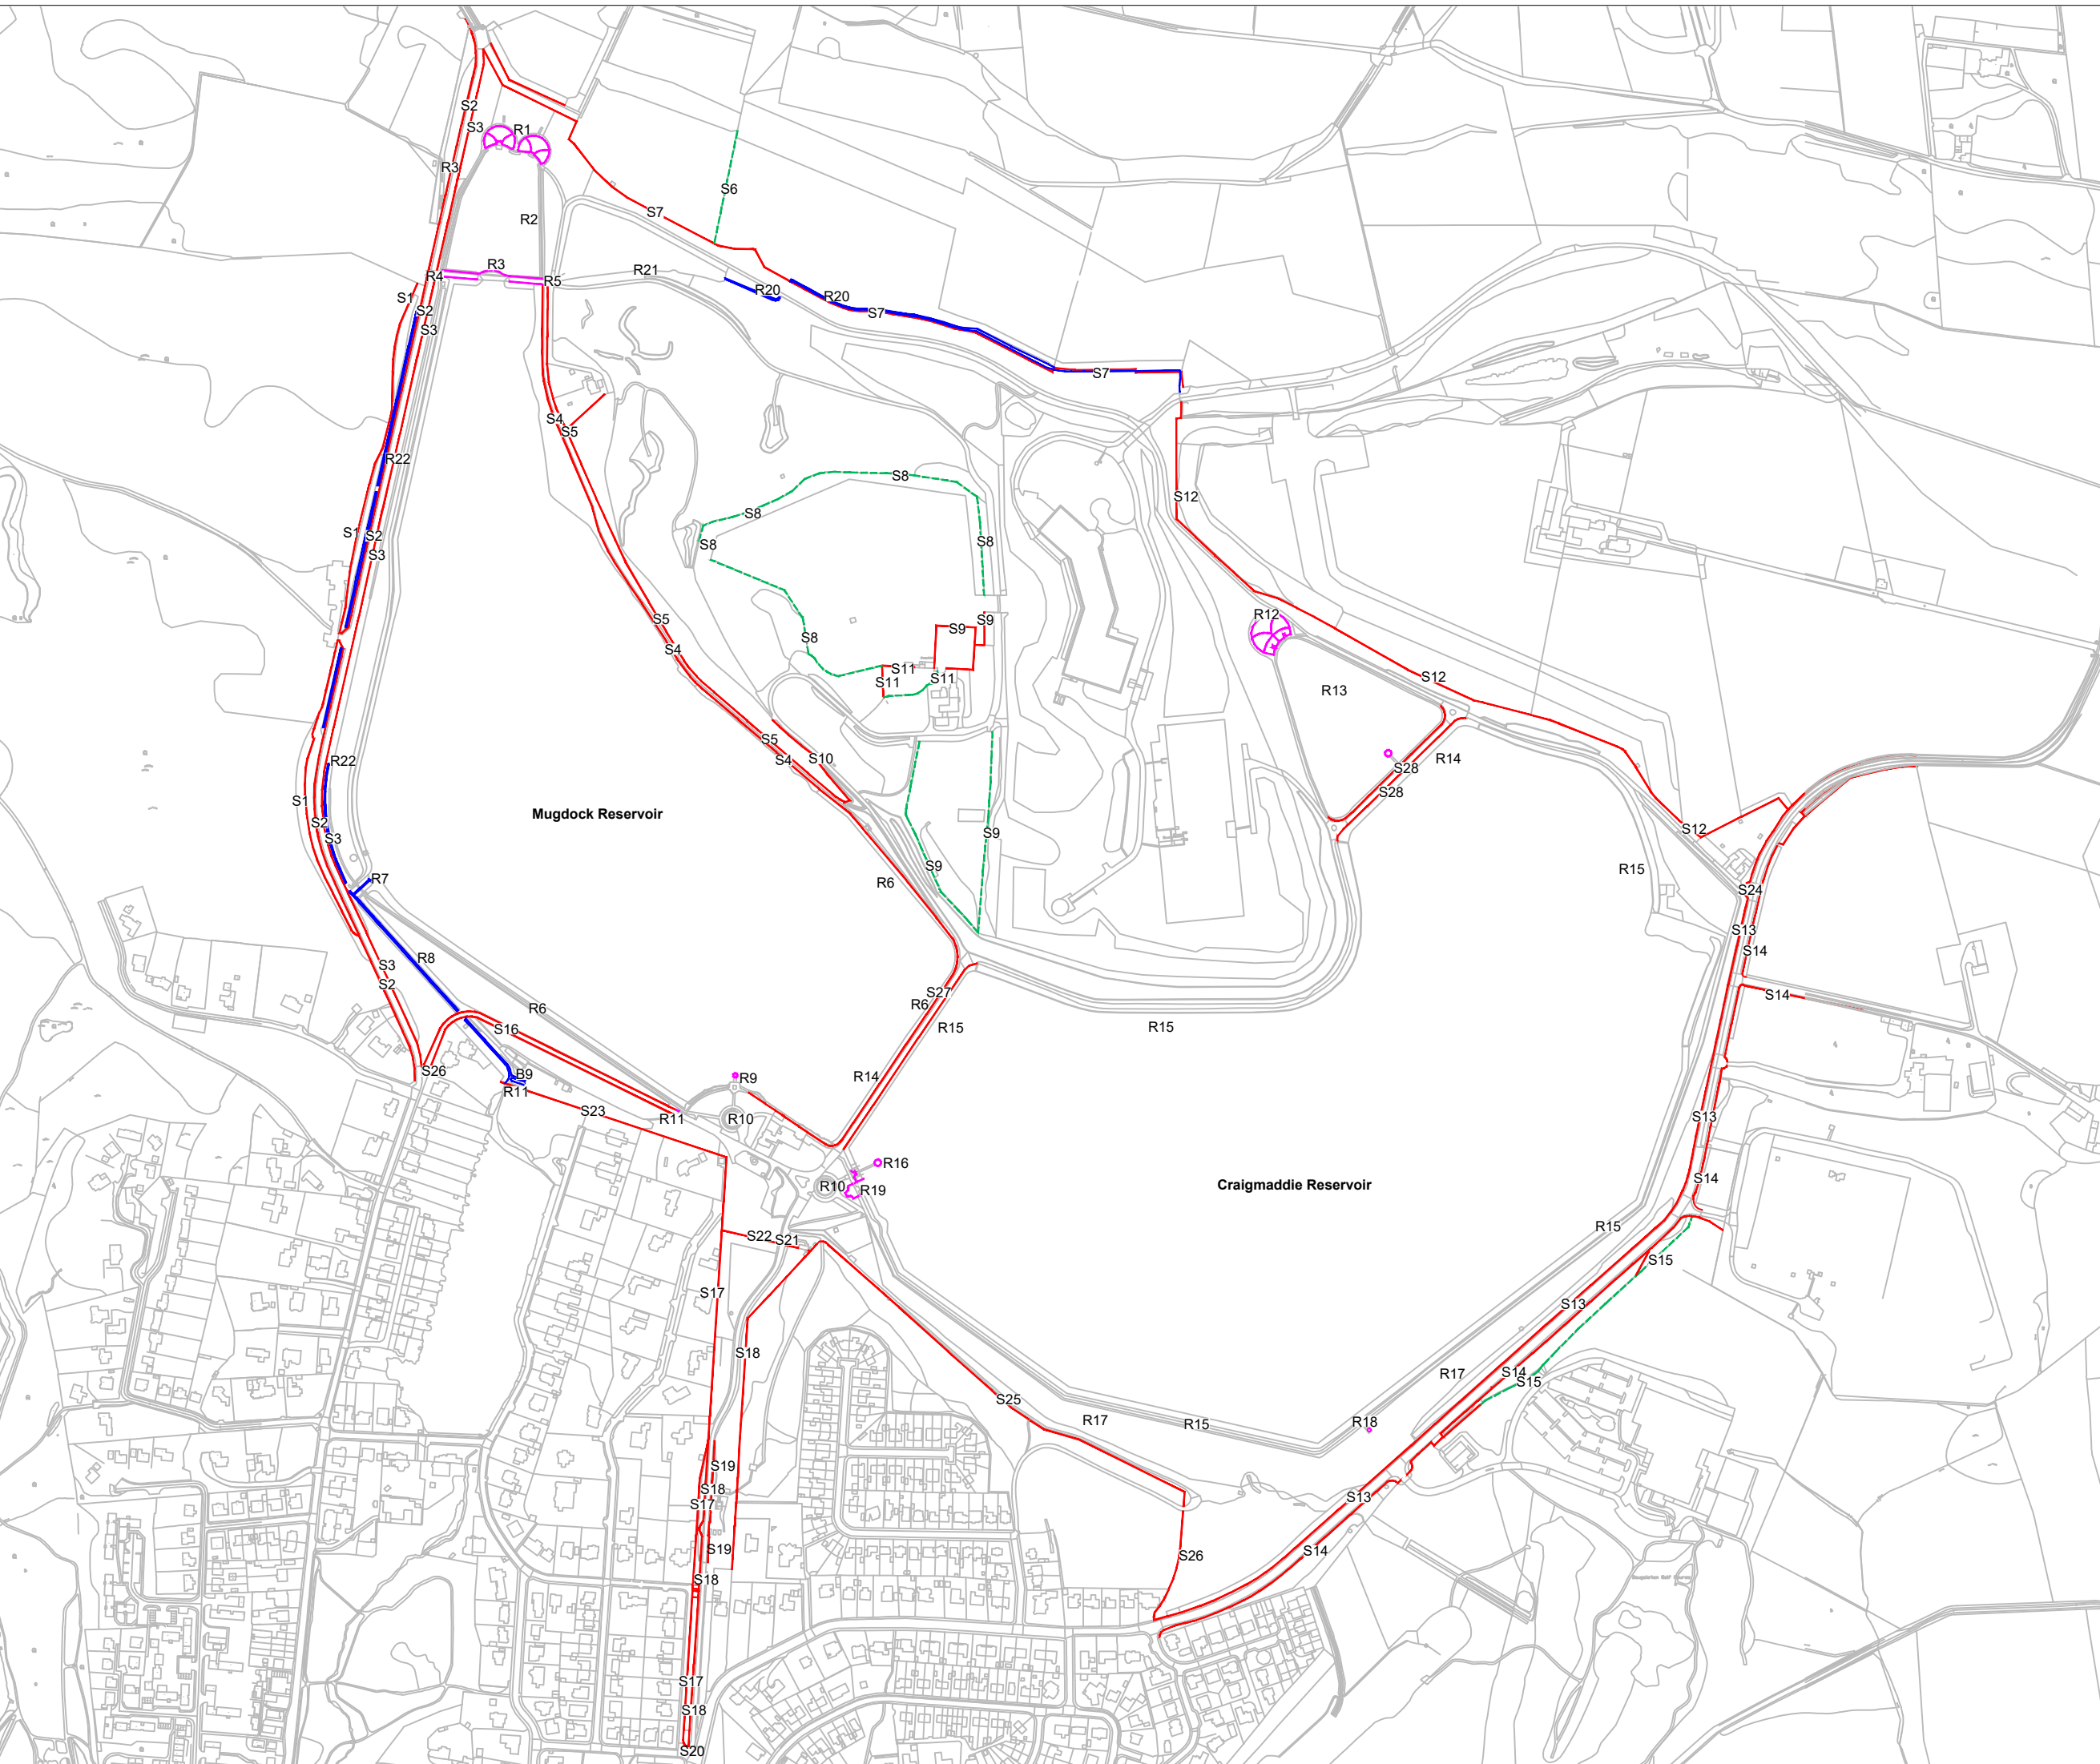
Fig. 4 Masonry

- self-seeded vegetation growth.
- localised subsidence.
- inappropriate cement pointing.
- damage from fallen trees and branches.
- some old field walls are unmortared and have been abandoned, but most mortared walls are in sound condition.

**3.55** Apart from the old field walls at Barrachan most of the masonry walls are intact. They have suffered, however, from localised damage, have loose/missing stones, vegetation growth or are locally subsiding. Cement pointing has been applied extensively in the past and this has been detrimental to the appearance and performance of the walls. Dead and diseased trees growing in proximity to the walls also presents a threat from falling branches or wind throw of the trees. Some trees and branches have fallen on the walls causing localised damage. There is a need to positively maintain these walls by embarking on a prioritised programme of remedial work which should address the high priority walls within a short time frame (next 5 years) followed by a second tier of priority between Years 5 and 10. Thereafter a rolling programme of wall works should continue to systematically undertake essential work. This would include removal of invasive vegetation, preventative removal of adjacent dead trees, repair of damaged and unstable sections of wall and removal of cement pointing to allow repointing with lime mortar. Self-seeded woody vegetation is a widespread issue where birch, ash, sycamore, and rhododendron take root within masonry joints, and if left unchecked can grow to destabilise the walls and eventually cause localised collapses. Softer vegetation such as Toadflax is not invasive or damaging and provides biodiversity value so should be retained.
